TECHNICAL SERVICE BULLETIN

HF35 Transmission - Thumping/Rubbing Or Grinding Noise

22-2396
24 October 2022

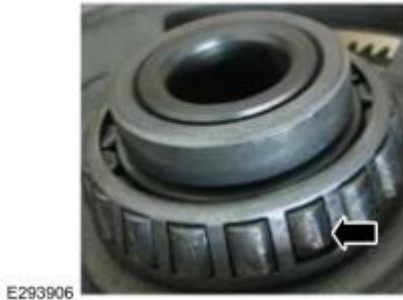
Figure 1

3. Remove the transmission assembly. Refer to WSM, Section 307-01.
 4. Disassemble the transmission and remove the rotors for a full internal inspection. Refer to WSM, Section 307-01.
- NOTE: Generator and traction rotors are magnetic so they must be placed on a non-magnetic surface away from one another.**
5. Inspect the damper housing for transfer shaft to housing contact. Is damage present on the damper housing from the transfer shaft?
 - (1). Yes - replace the damper housing and transfer shaft using the transfer shaft repair kit. Follow the repair kit procedure. Proceed to Step 7.
 - (2). No - proceed to Step 6.
 6. Inspect the differential bearings. Is there any noticeable roller bearing damage? (Figures 1-2)

- (1). Yes - replace the differential bearings, clean transmission of any internal debris. Refer to WSM, Section 307-01.
 - (2). No - proceed to Step 7.
7. Inspect the input gear bearings. Replace the input gear assembly if any damage found.
8. Remove the generator rotor to inspect the planetary assembly. Refer to WSM, Section 307-01.
9. Inspect the forward input planetary assembly. Is there any damage to the gear or bearing?
 - (1). Yes - replace the planetary assembly.
 - (2). No - clean and reinstall planetary assembly.
10. Reassemble the transmission. Refer to WSM, Section 307-01.
11. Reinstall transmission assembly. Refer to WSM, Section 307-01.
12. Flush the transmission fluid cooling system. Refer to WSM, Section 307-01.
